# **Antioch College Buildings Consultant Team Report**

**October 1, 2009**

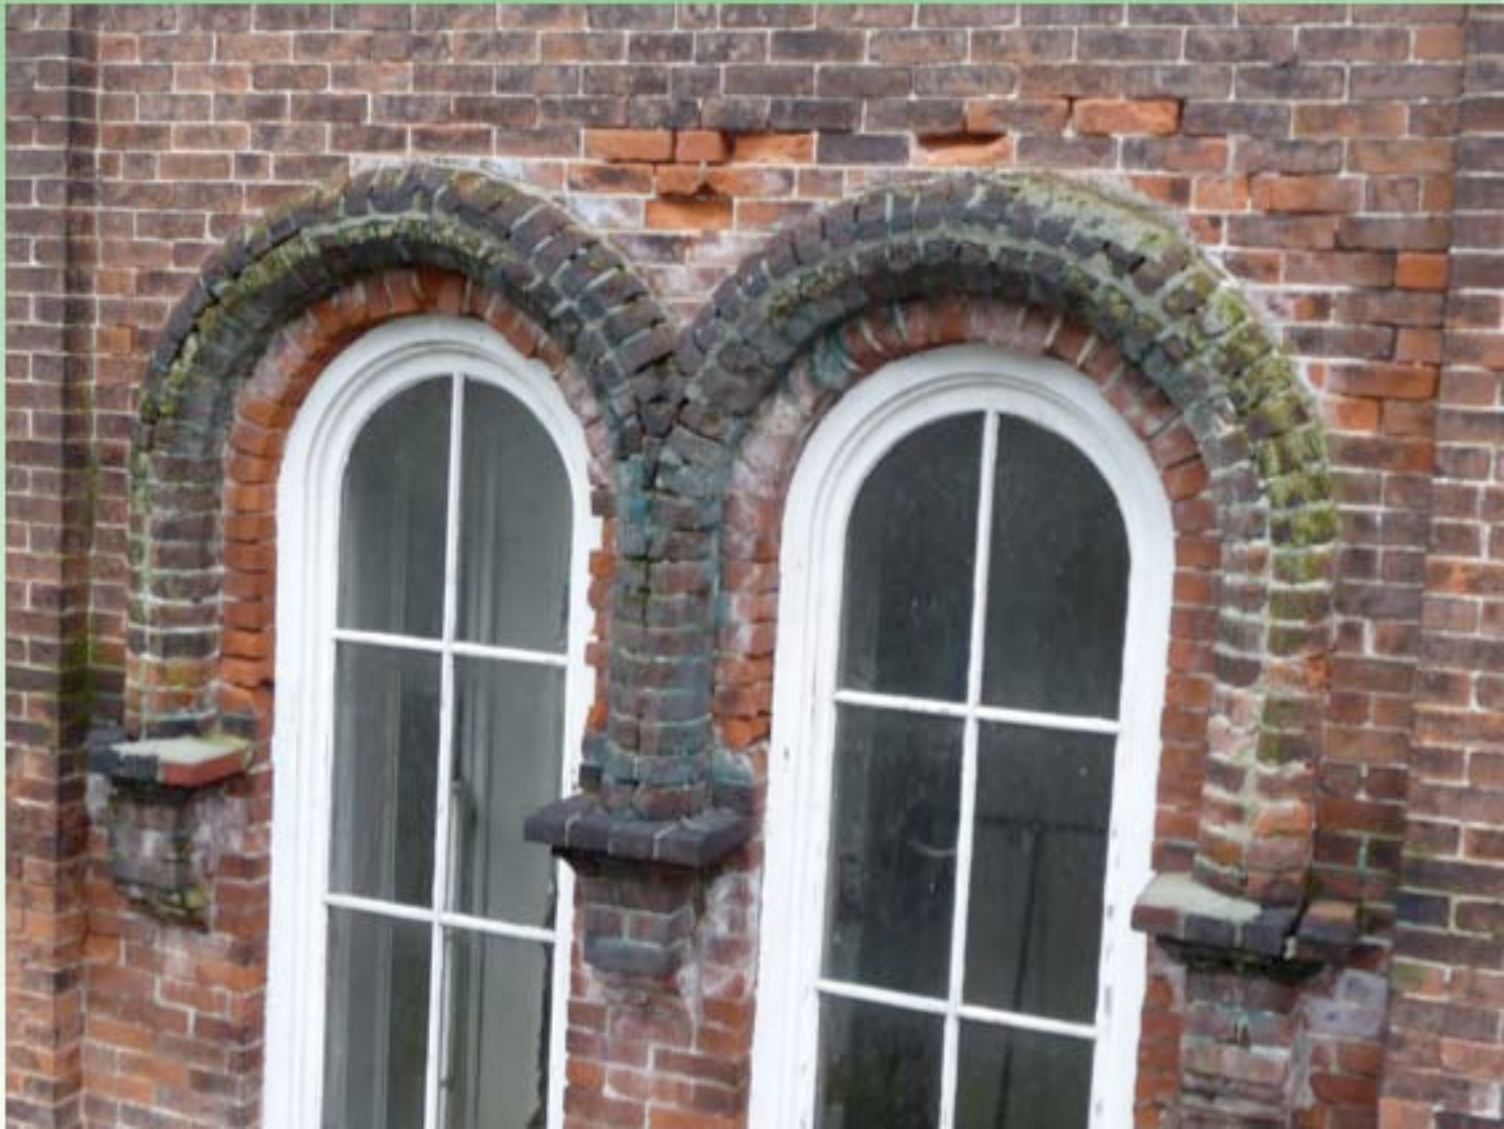
Green stain adjacent to downspout. Causes are a combination of blocked or constricted underground drains, blocked downspouts (from plastic snow guards), undersized gutters and downspouts, and inadequate deflector at valley intersection with gutter.

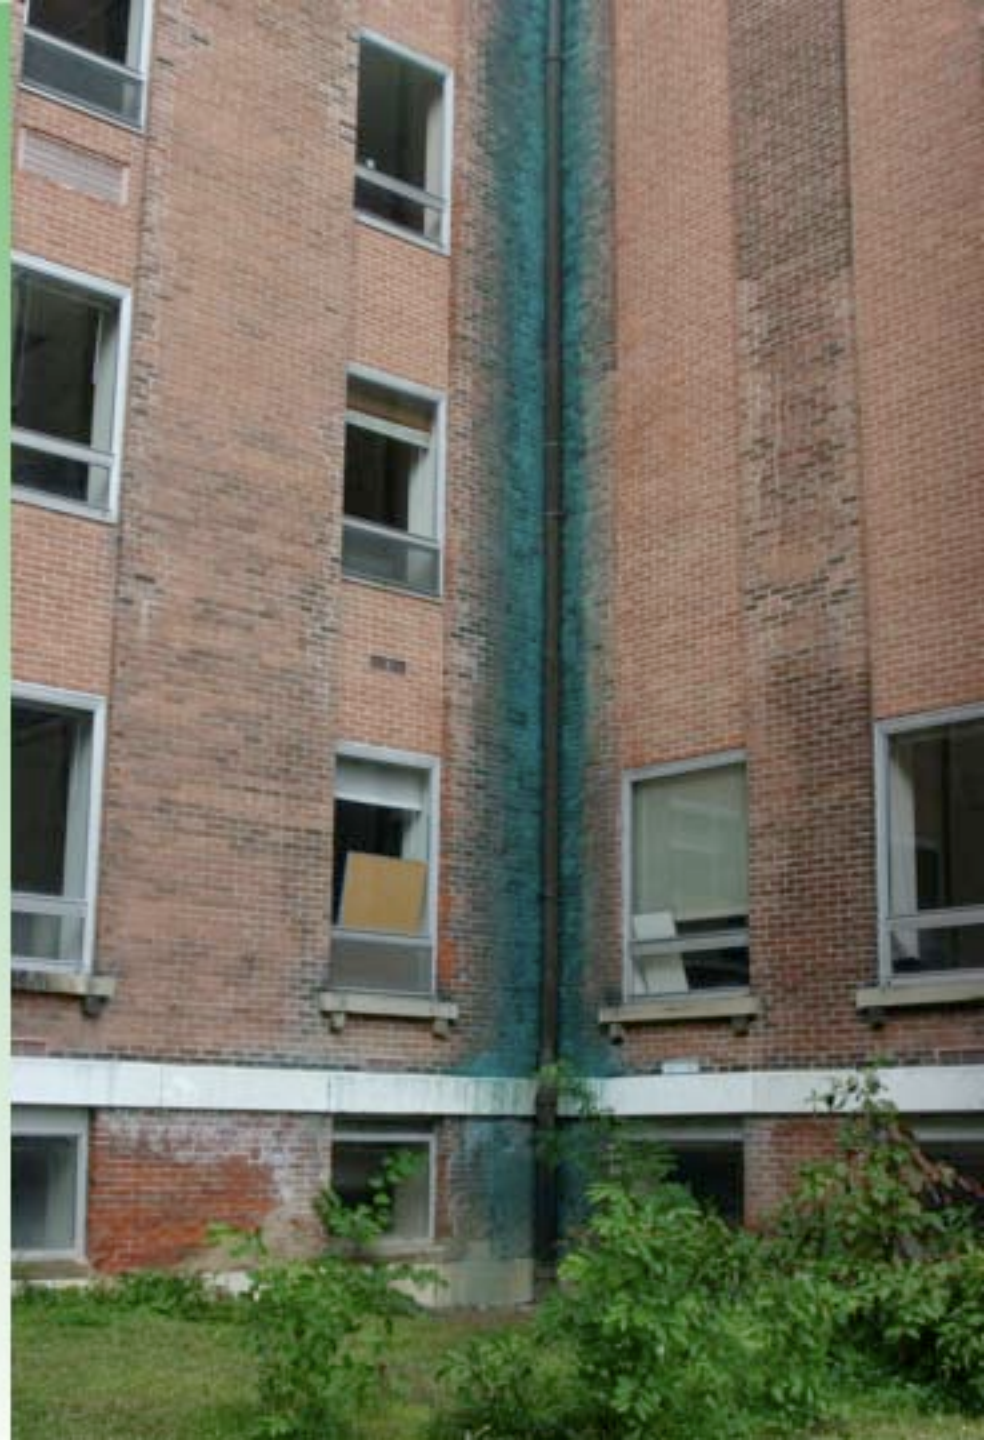
Detail of Roof Downspout, header box, feeder downspouts, and deflectors.

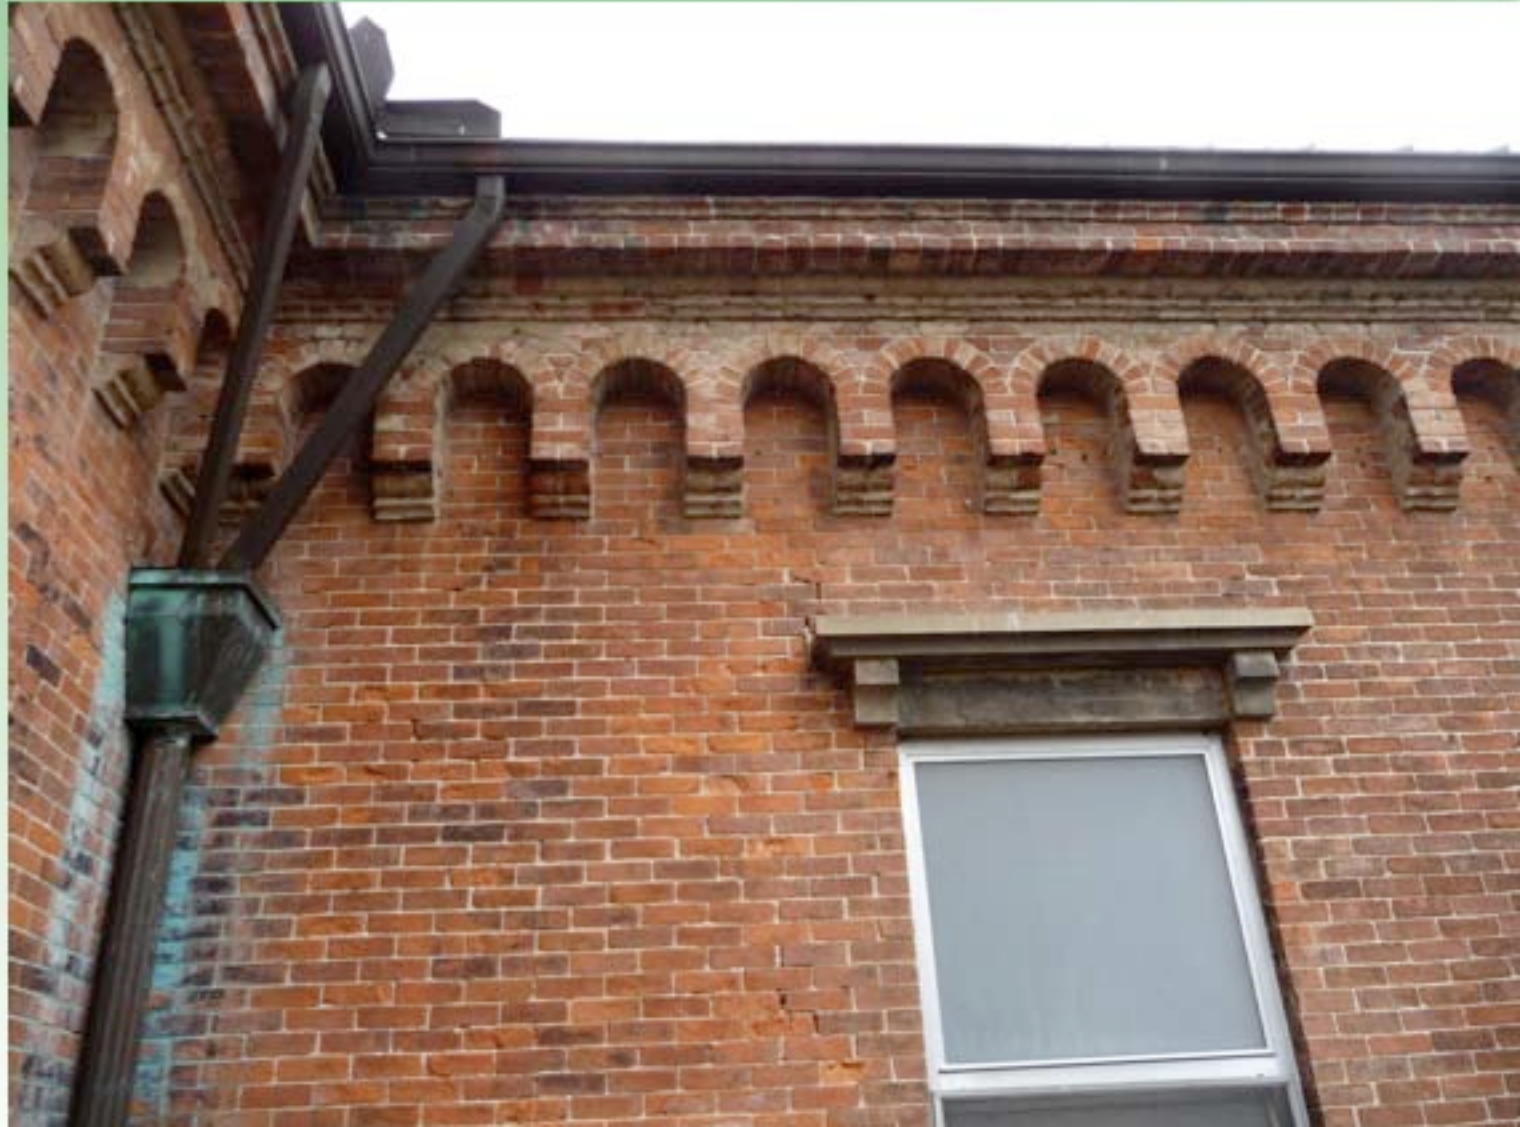
Detail View of Uncontrolled Roof Drainage from Back of Turret. Note black stains and green stains. Also note that the top surface of the lower copper detail is dished inward. Probable cause is ice impacts from above or workmen standing on the surface.

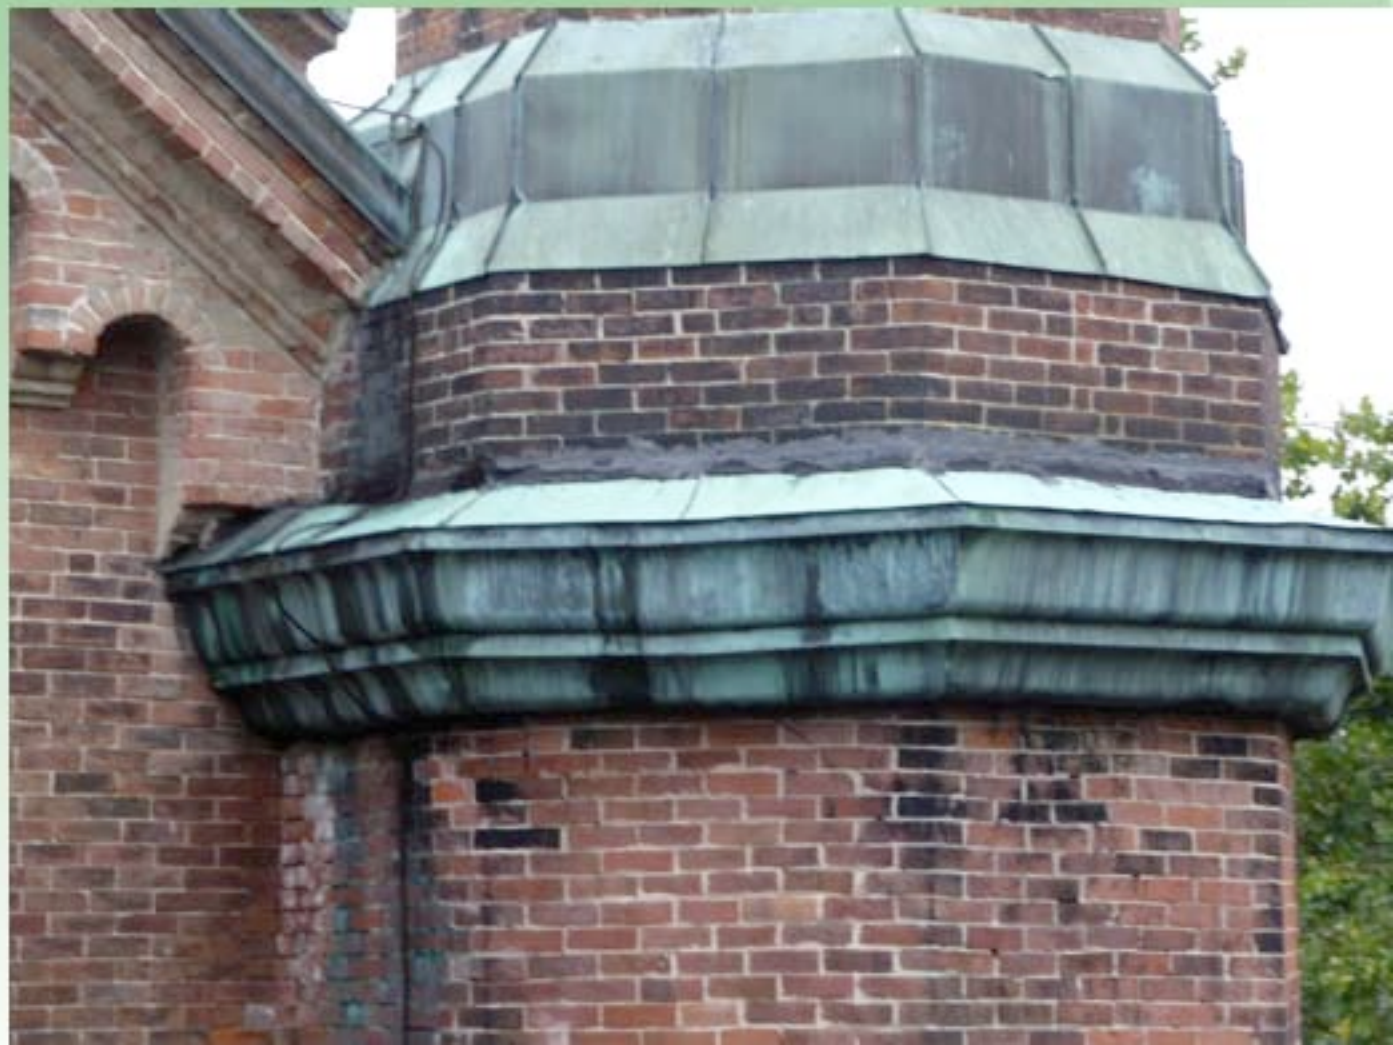
Salts can blow off the face of a brick as seen here at the base of the west wall of the south wing.

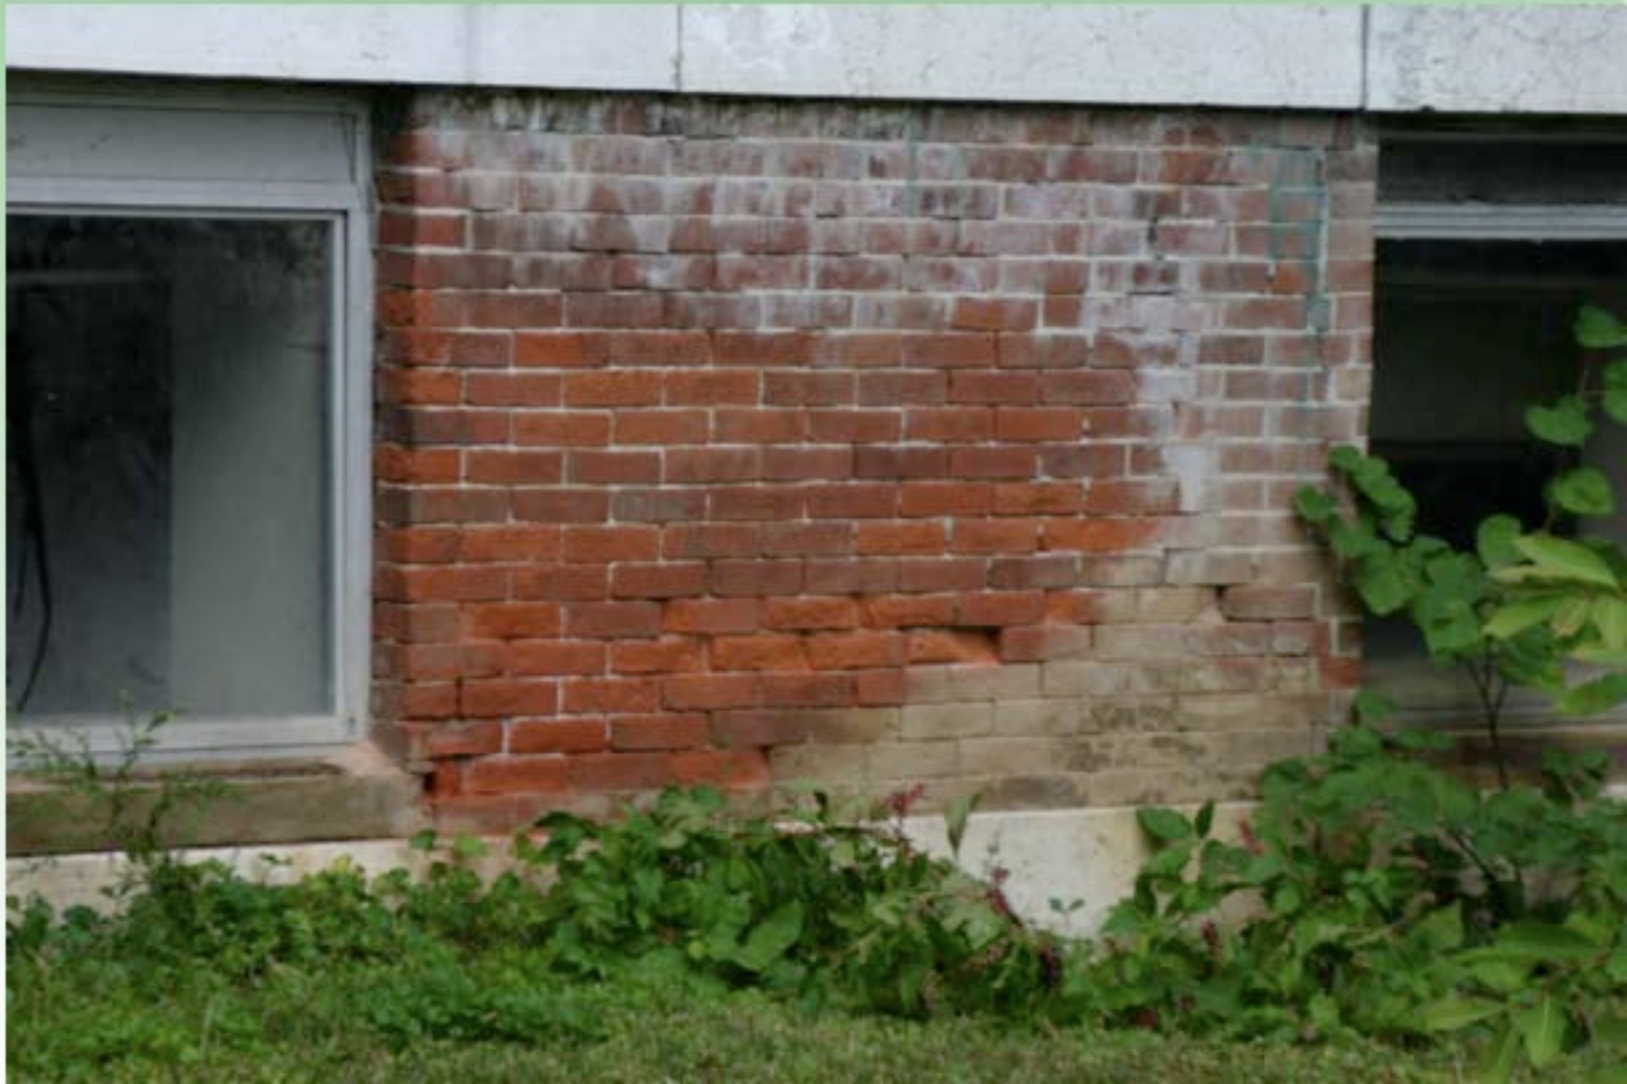
Salt at top of wall, rising damp and freeze/thaw at mid-height, and copper staining at bottom.

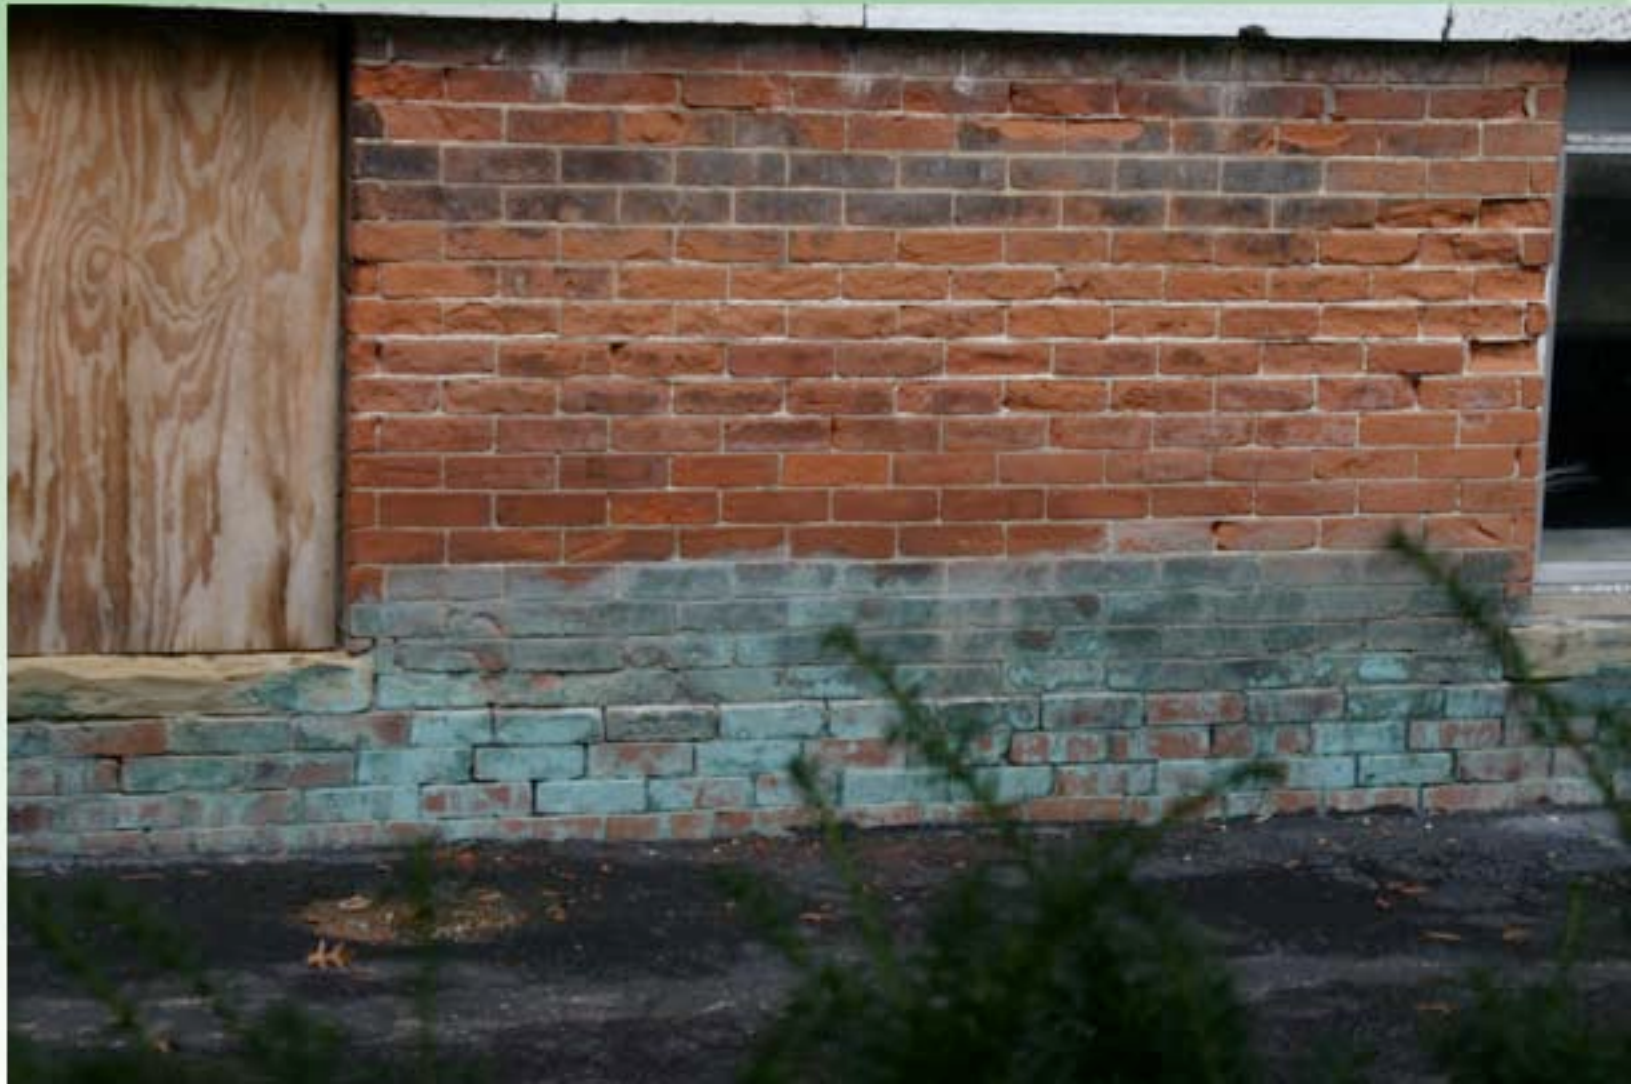
Spring Point of Arch Damage. Snow sits on the original detail, now lost, melts, and resultant freeze/thaw destroys brick.

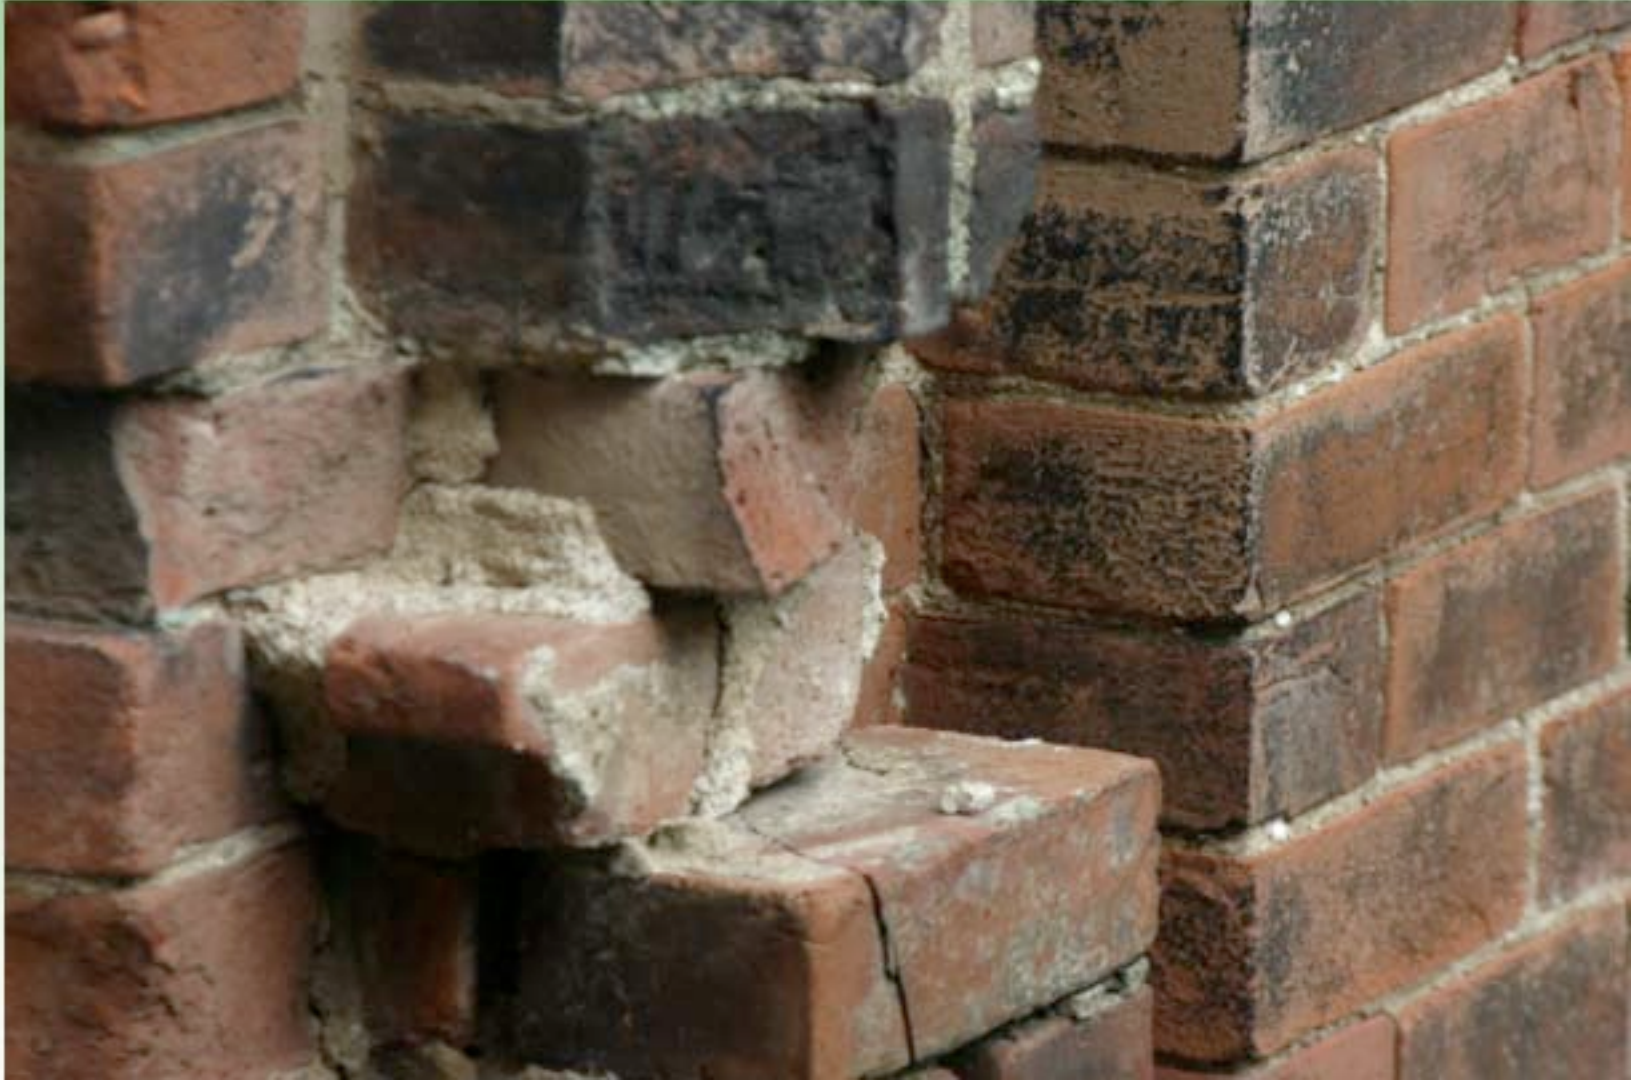
Crack. The displacement from the crack in the stone below has radiated up through the brick. Cracks such as this are generally cause for concern so we tested to determine what were the stresses in the wall.

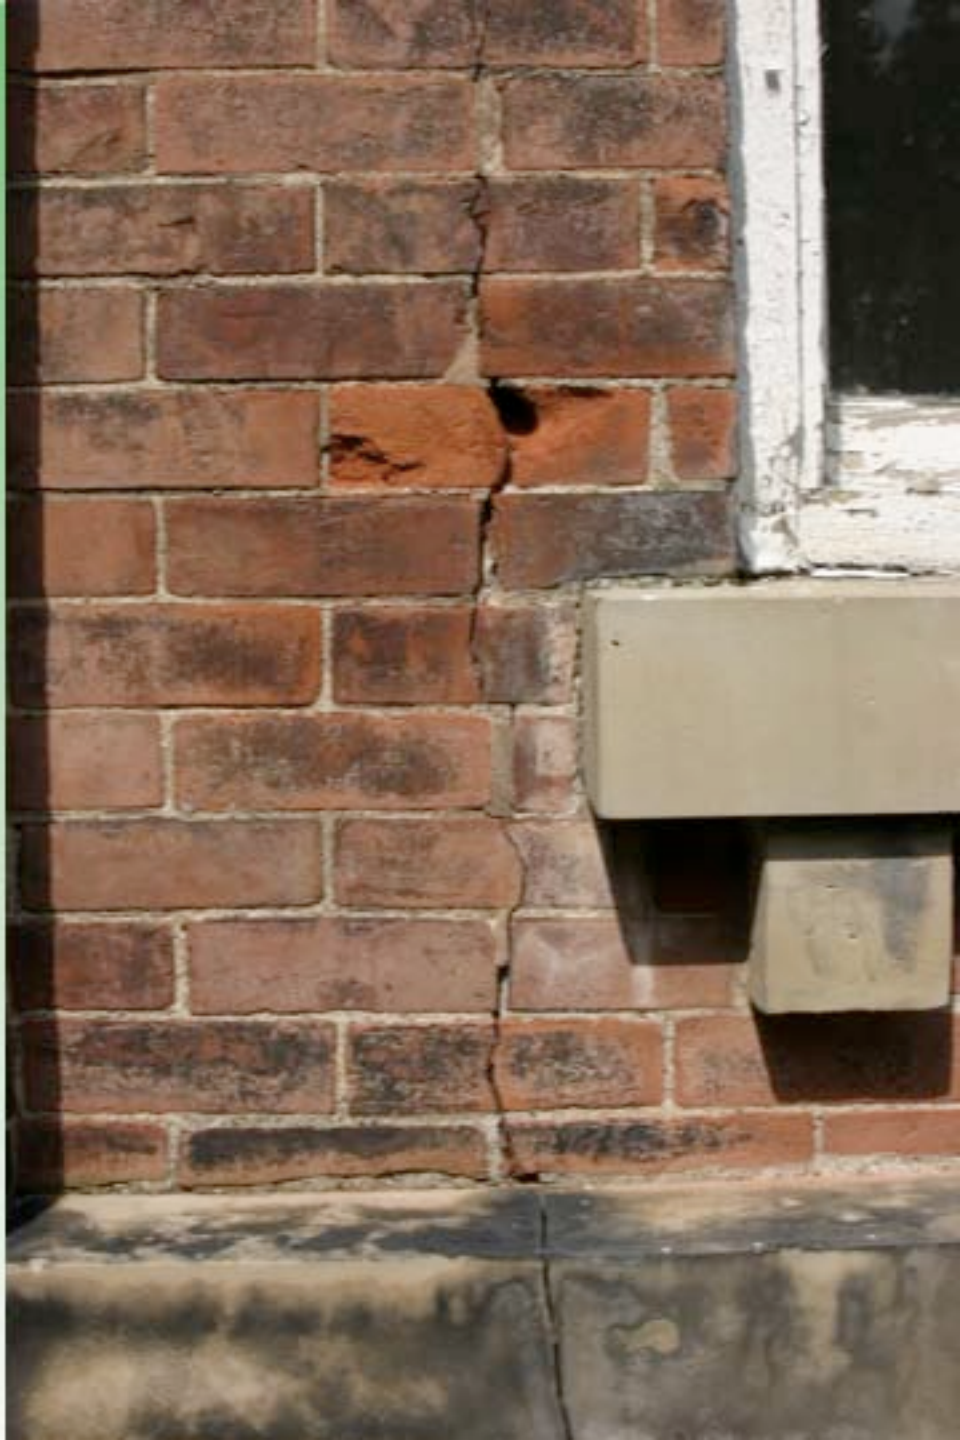
Crack. Notice the similarity to the previous photograph. However, in this case there is some downward deflection in the brick courses to the left of the window sill.

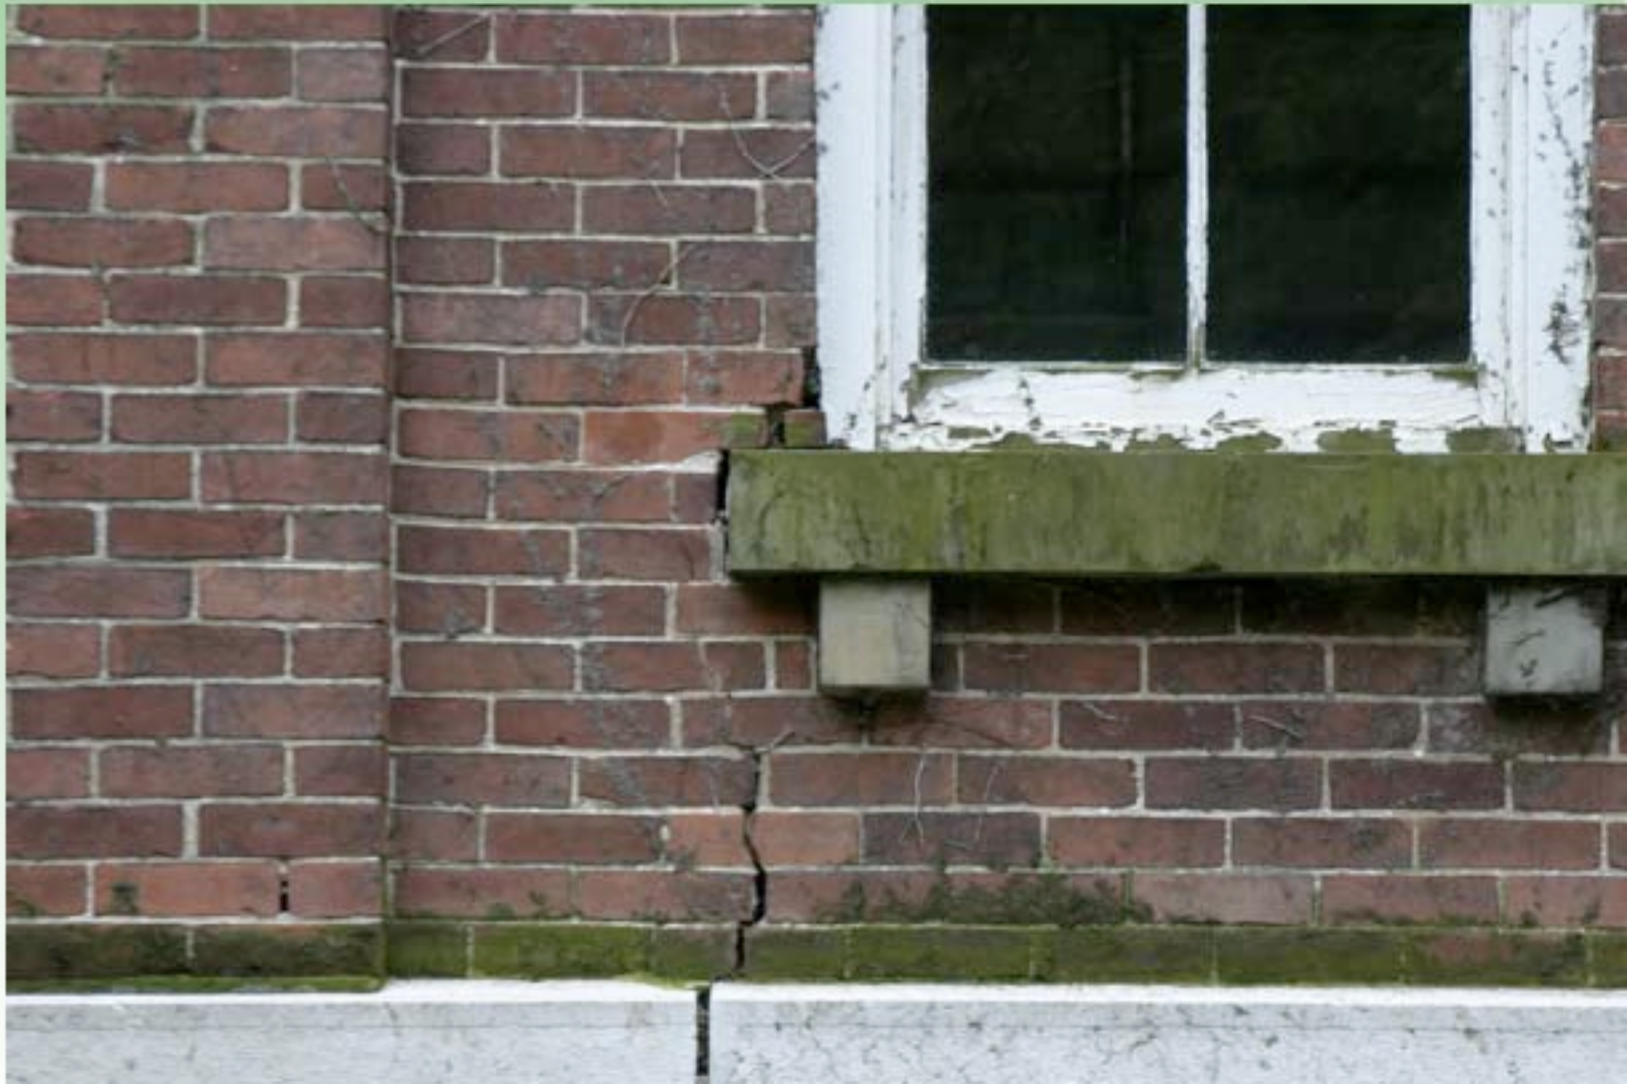
Detail to Illustrate Common Condition of Historic Window Frames. Paint samples were taken in order to determine original color.

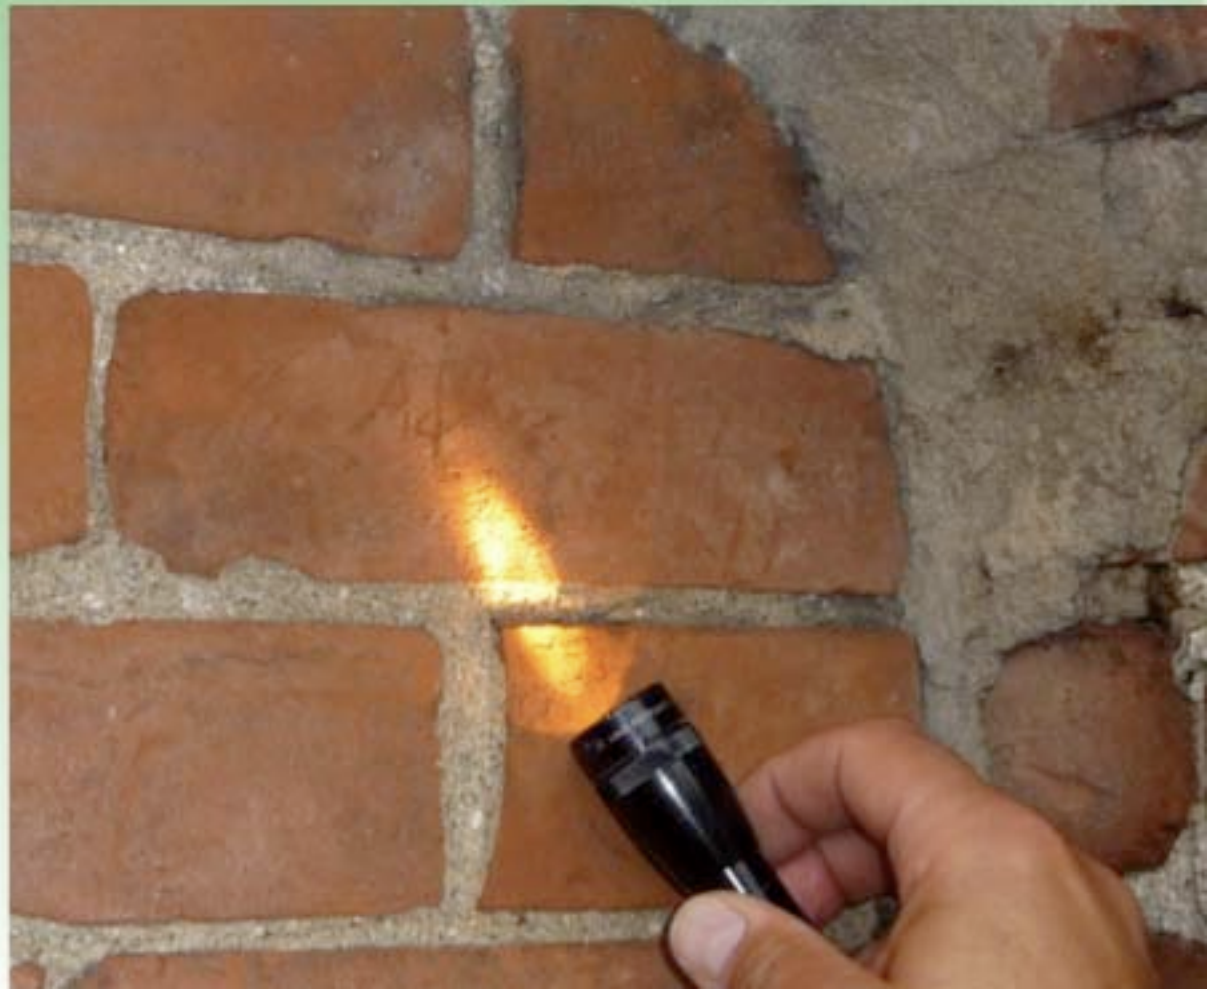
By accessing the building with a high lift, we were able to assess the conditions more completely. One curiosity, this brick was signed by one of the masons. It is typical for masons to leave their mark.

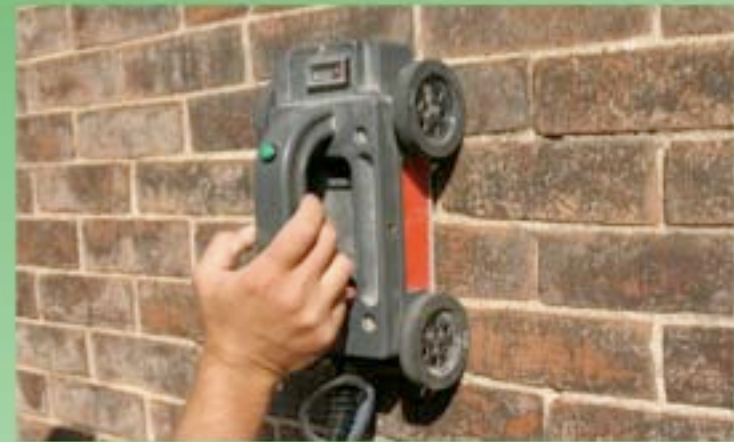
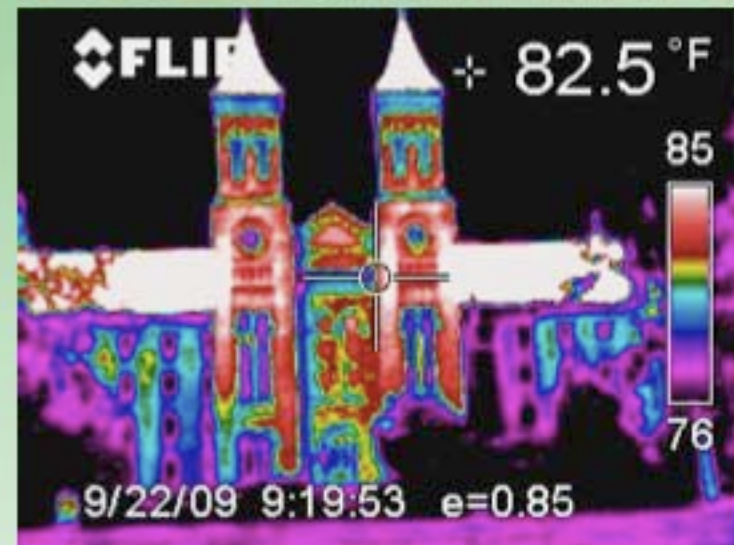
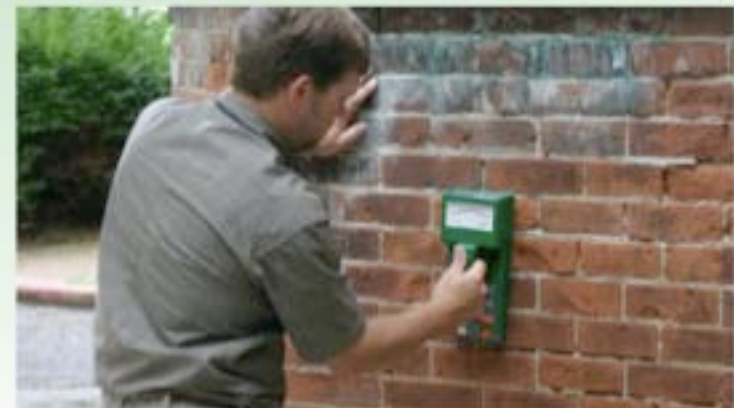
Brick Erosion

- Base of building - throughout
- Isolated areas above
- Moisture-related phenomenon
- Freeze-thaw cycles
- Salt crystallization, cryptoflorescence

- Roof drains, gutters
- Eroded brick
  - Base of wall
  - Elsewhere on building
- Cracks
  - Stitching
  - Localized mortar repointing
- Retrofit ties
  - Isolated locations only

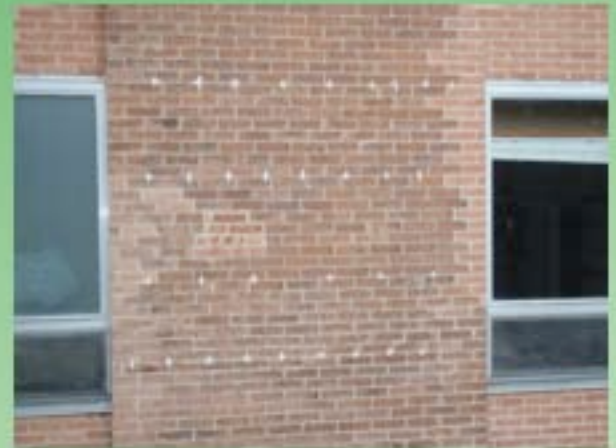
Most locations: regular tie spacing

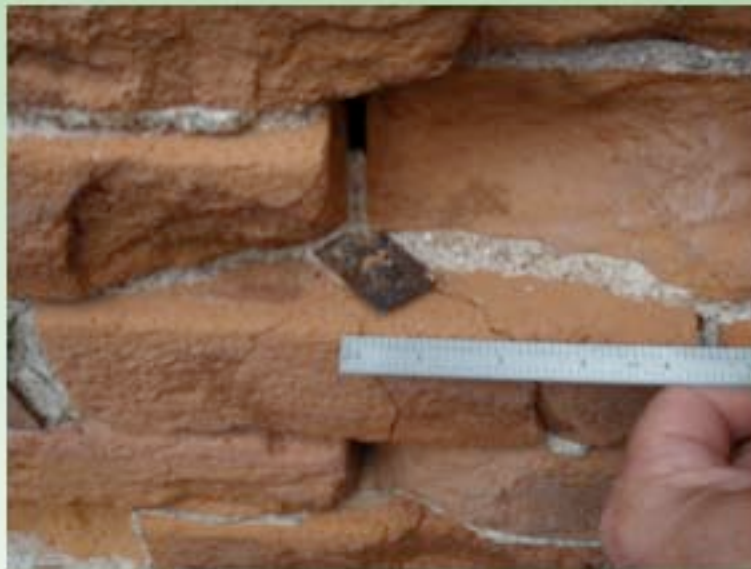
Moderate corrosion  
Corrosion-related expansion: brick  
damage at one location

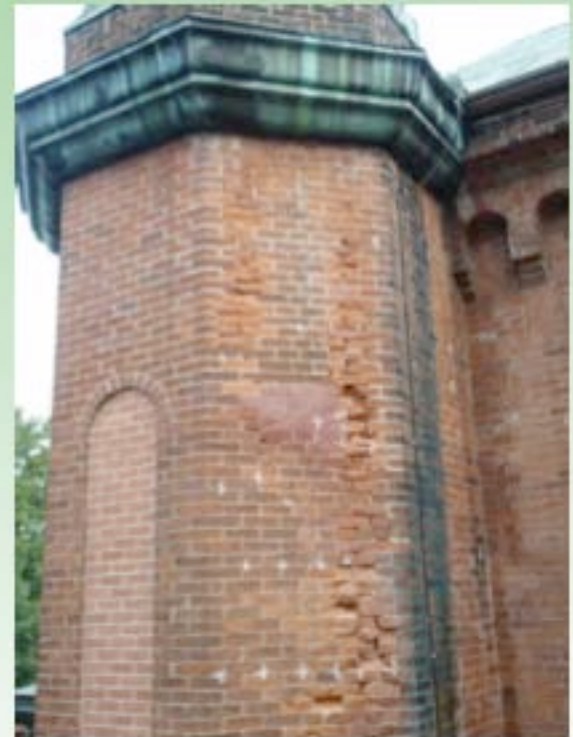
Other locations: faulty tie installation

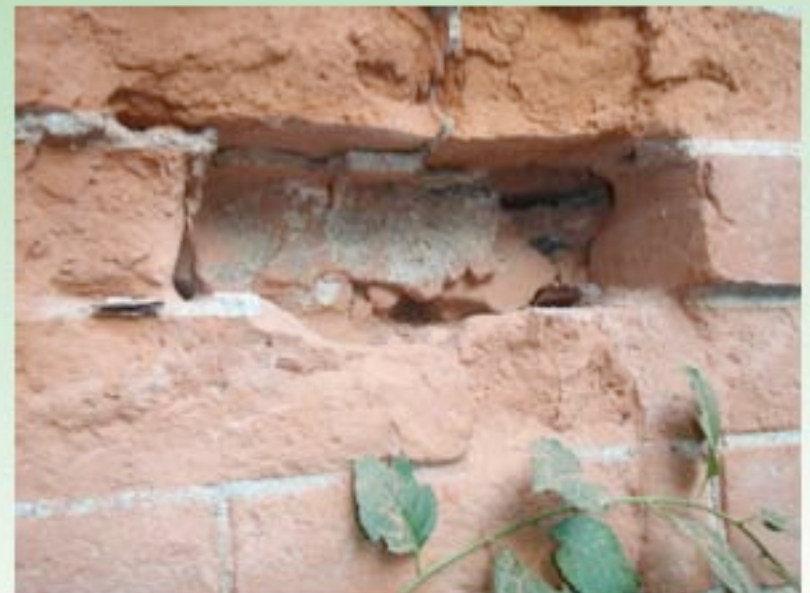
Microwave Radar, Borescope

- Wall construction solid masonry throughout entire wall thickness
- Small internal voids present at some locations

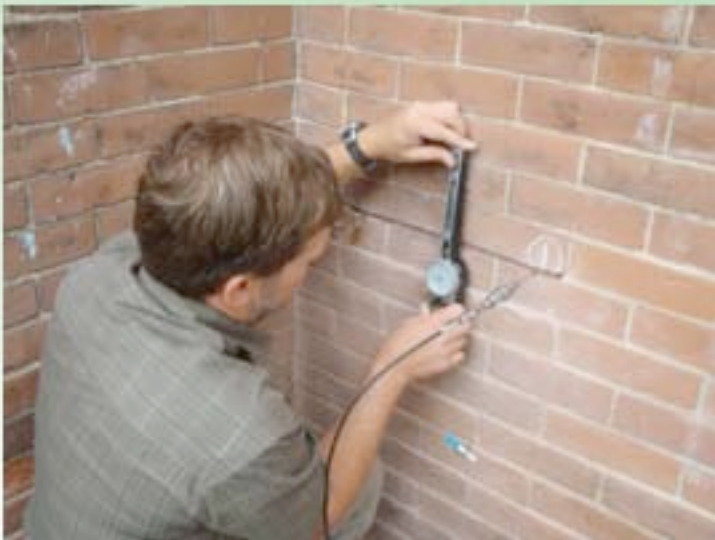
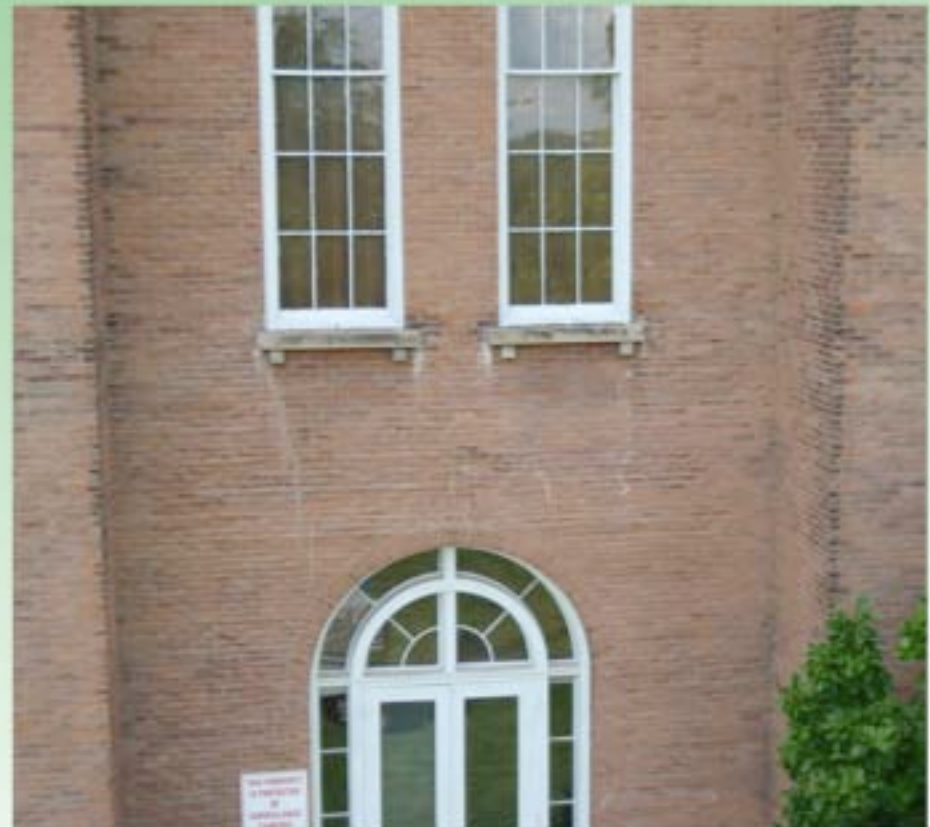
## Flatjack testing

- Compression stresses slightly high
- Cracks likely not due to compression overload

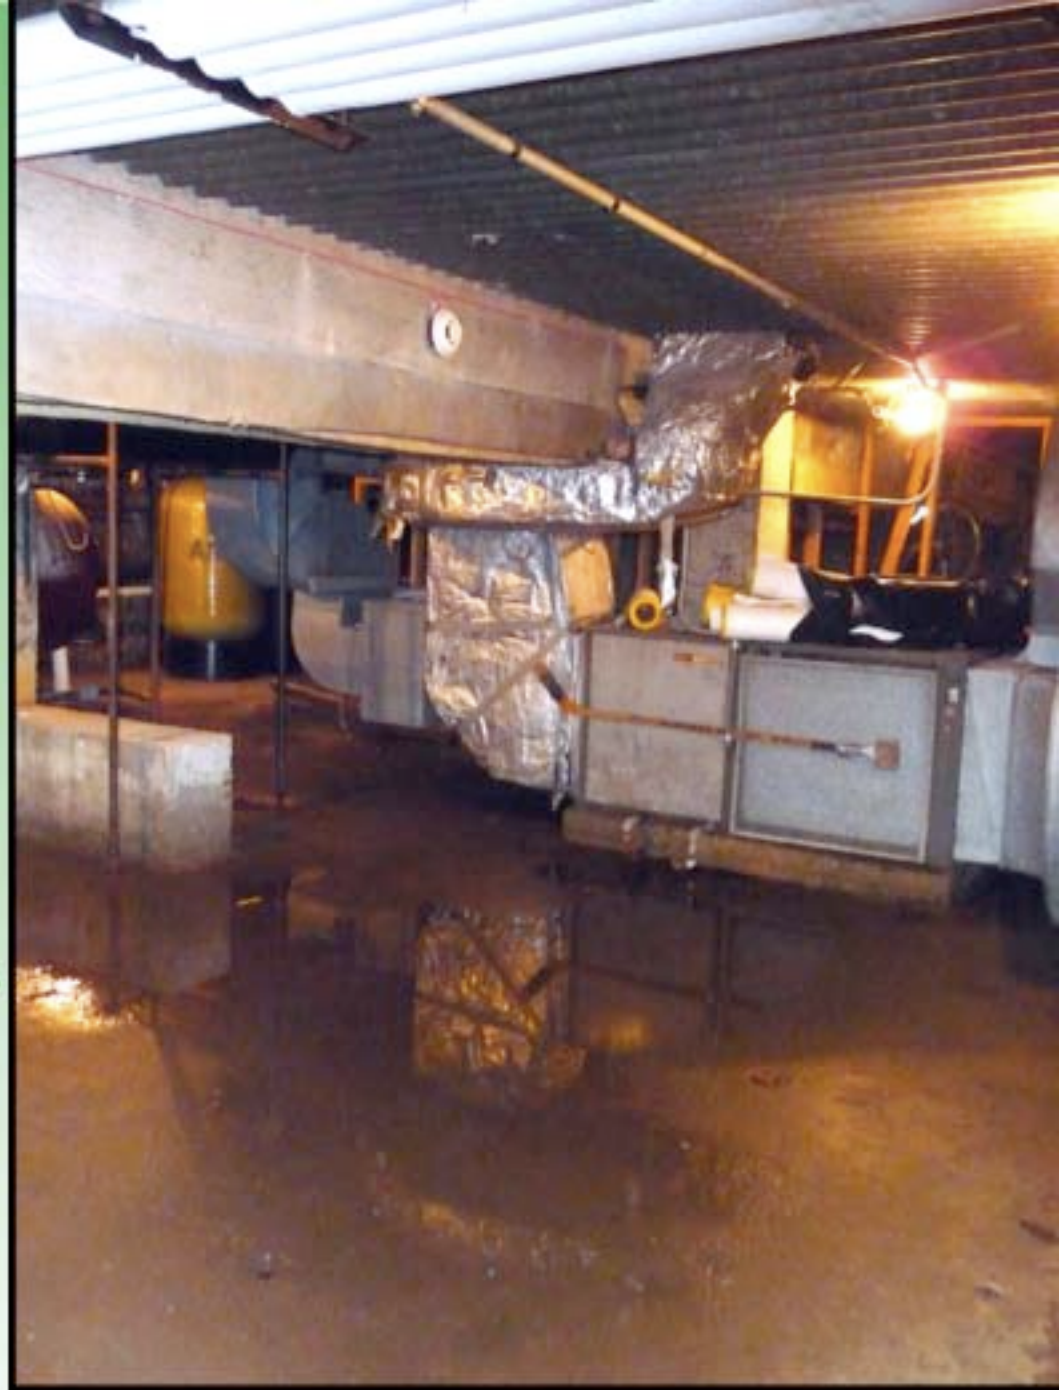
## Geothermal Systems

- Provides both heating and cooling
- Exterior air cooled chillers no longer on campus
- Bore field is "invisible"
- Coefficient of Performance  $COP = \frac{\text{Beneficial Energy Received}}{\text{Energy Purchased}}$
- COP of 3 to 4 common
- COP of 4 + Four units for the price of one,  
IE three free units
- Byproduct of producing heat is cooling
- Byproduct of producing cooling is heat.
- If Cooling and Heating can be consumed at same time, COP is Additive,  
IE  $3+3 = 6$
- Bore Field on Quad could serve 5 buildings
