# **Antioch College Buildings Consultant Team Report**

**October 1, 2009**

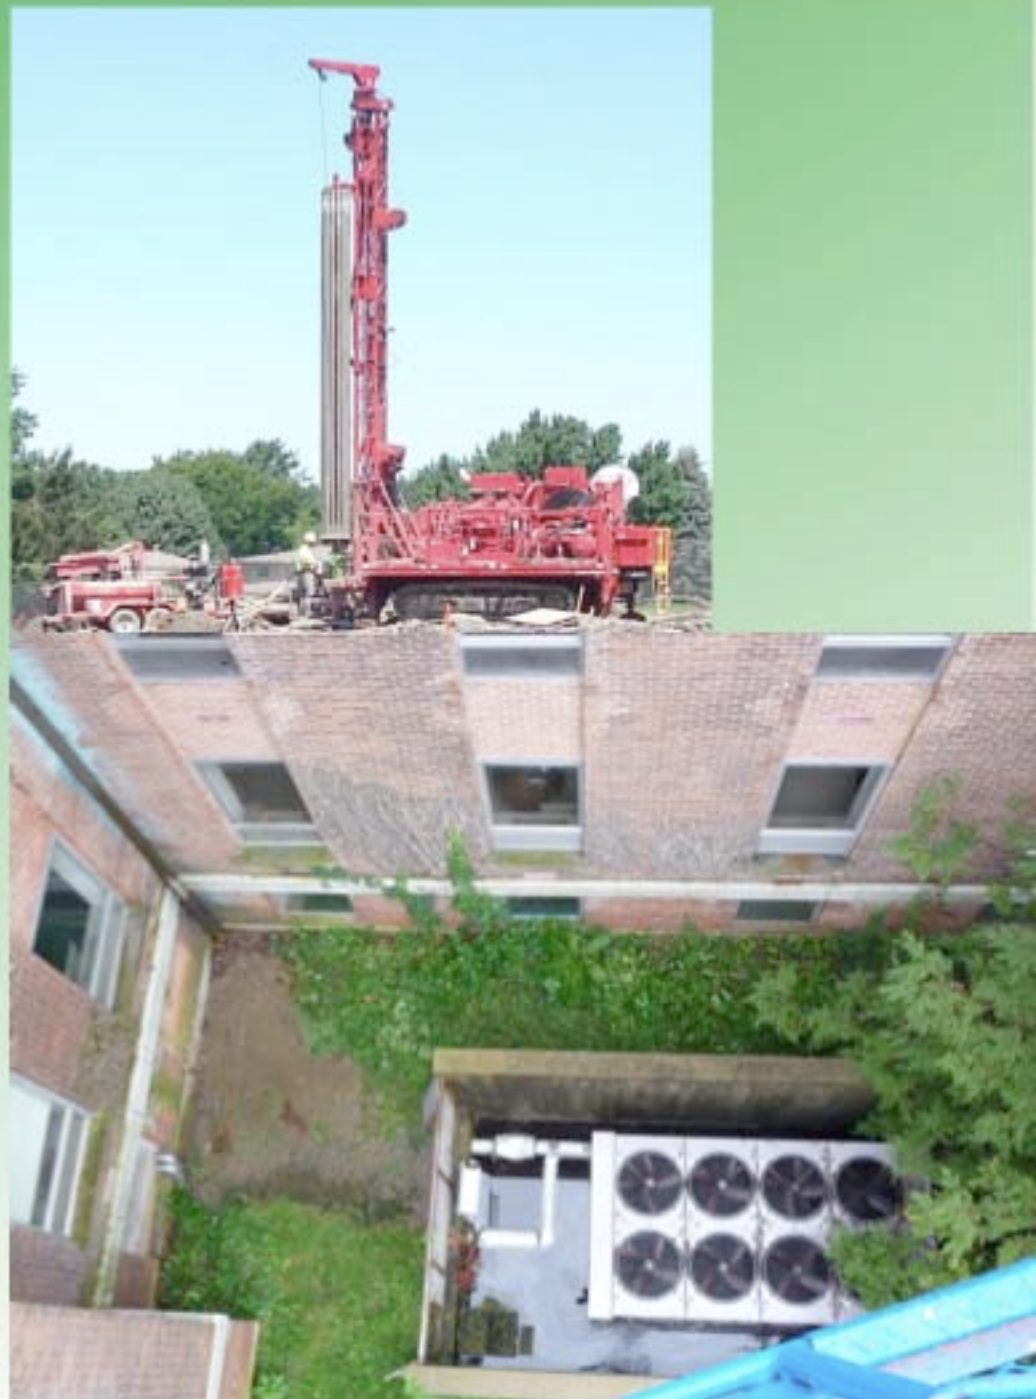
## McGregor Possible Mechanical Systems (Geothermal)

- Convert Dual Duct Air Handling Unit to VAV
- "Fire" Hot Deck and Cold Deck with Geothermal
- Geo HW and CHW water to water heat pumps
- Convert Dual Duct boxes to VAV
- Ductwork and zoning remains the same
- or
- Replace Dual Duct boxes with Geo Heat pumps
- Remove AHU and ductwork to Dual Duct Boxes
- Provide minimum outside air system
- Ductwork and zoning down stream of the pumps remains the same.

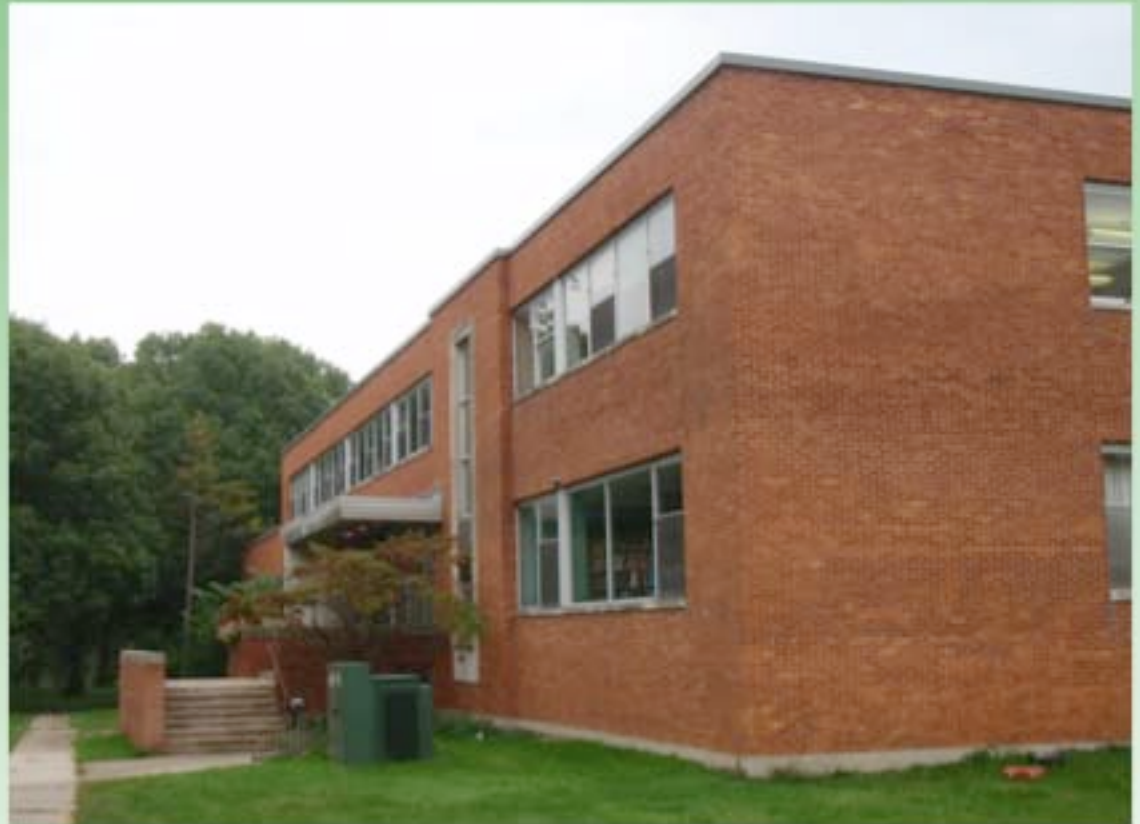
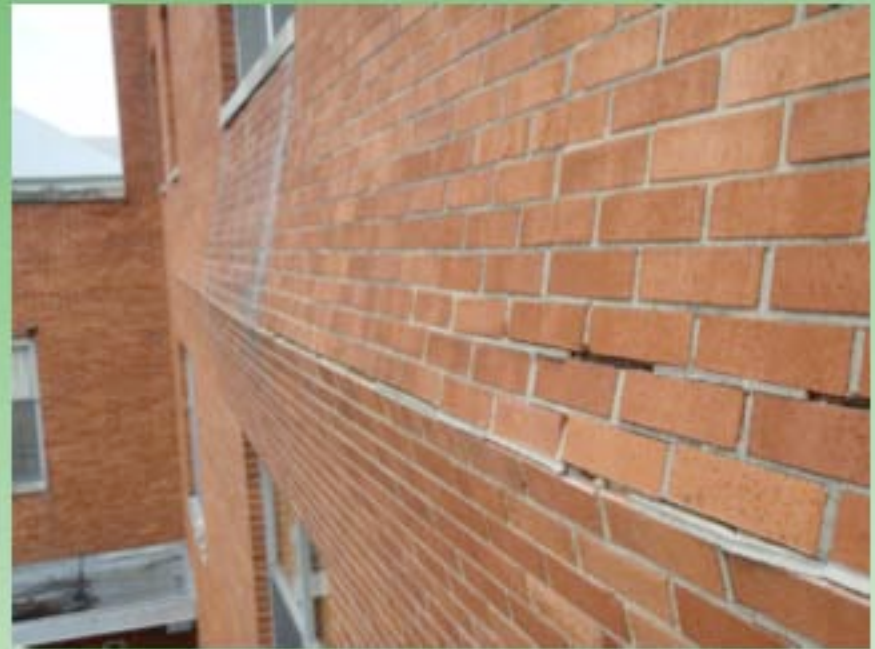
- Brick cracking throughout
- Foundation cracks at corners

**Brick expansion towards  
corners:**

- Moisture expansion
- Thermal movement
- Freezing expansion

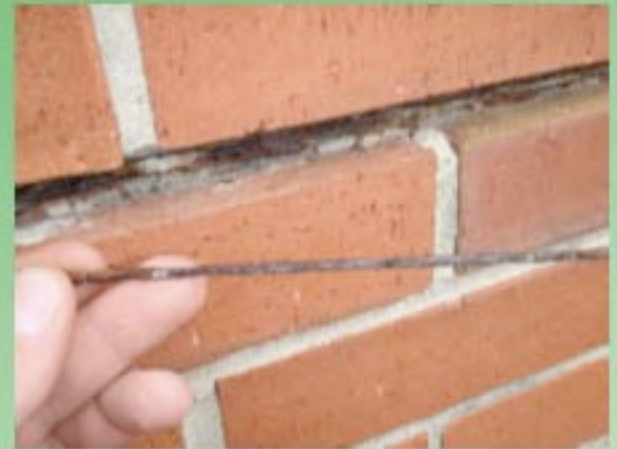
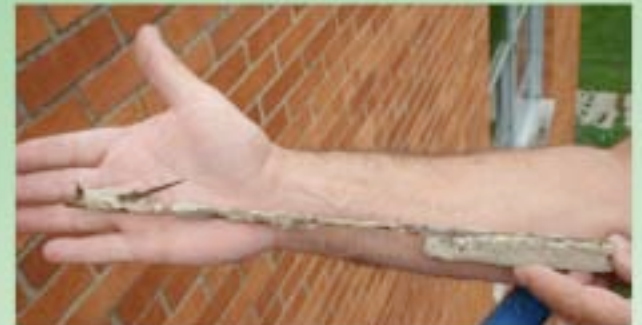
- Joint reinforcement near tops of walls severely corroded
- Remove corroded joint reinforcement
- Install retrofit ties for new connection
- Install new expansion joints
- Rebuild severely displaced masonry at south elevation
- No foundation work required
- No structural work required

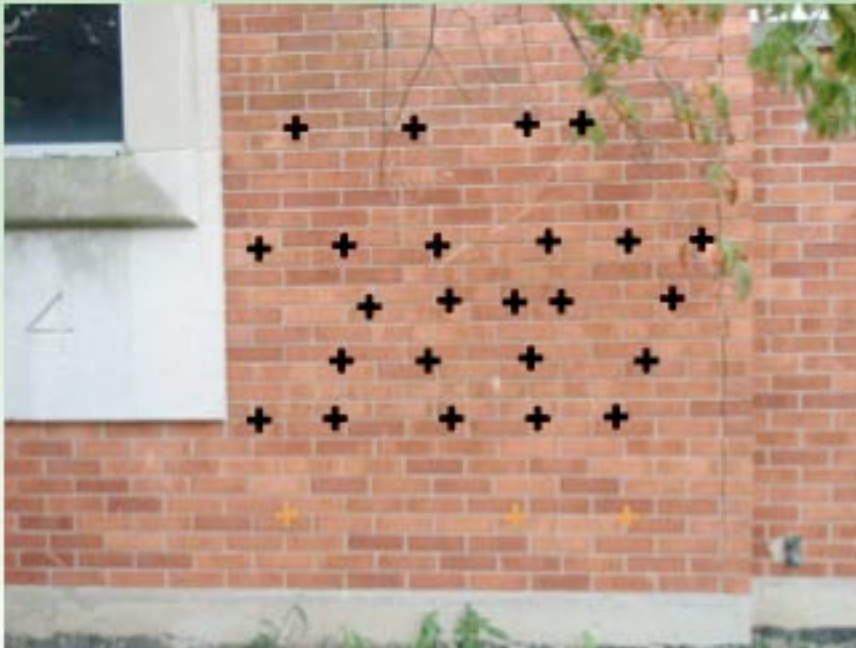
- Corrugated ties used at most of the building
- Improper tie spacing, ties not placed in mortar joints, ties missing altogether at some locations
- Retrofit ties needed at missing locations

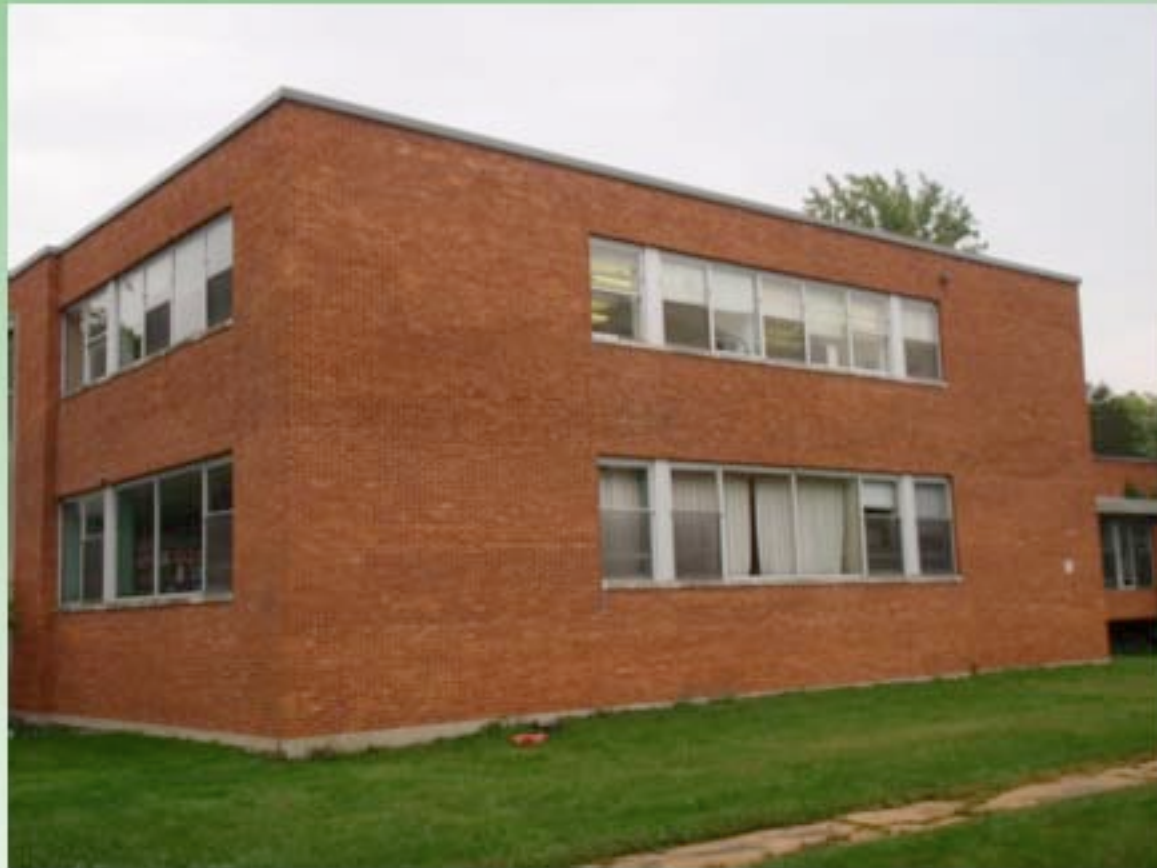
- Drainage cavity construction
- No flashing or weep holes
- Install flashing and weeps at window lintels, base of wall?

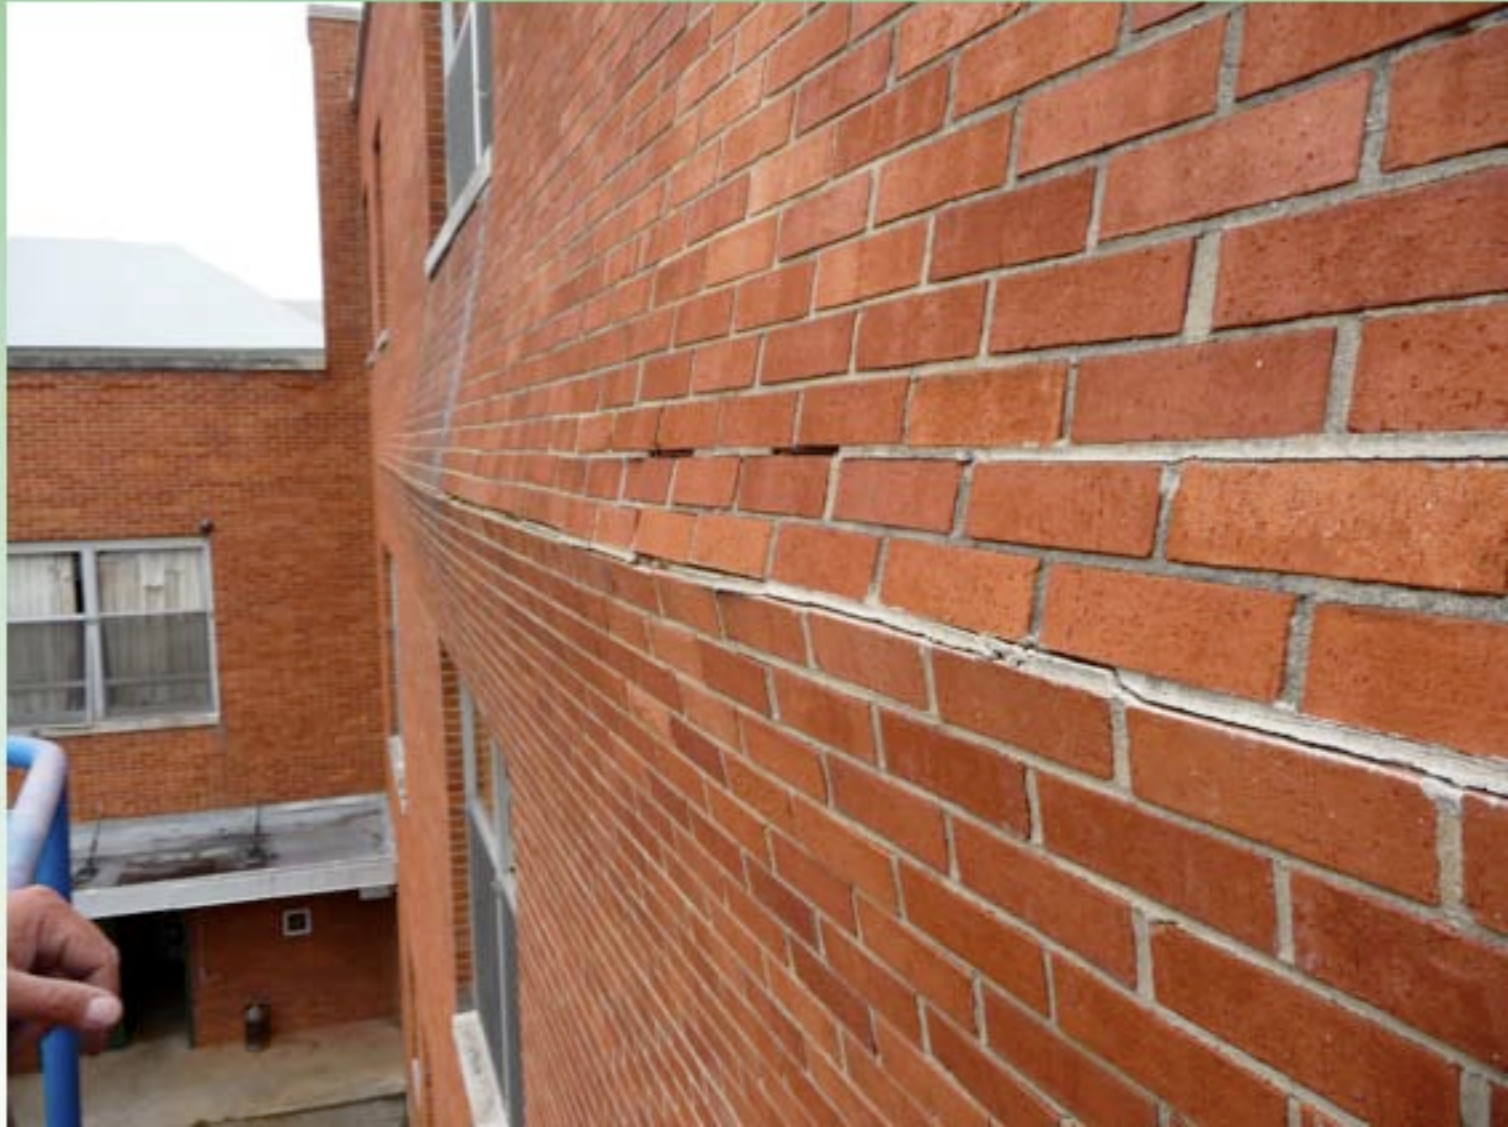
A true disconnect.

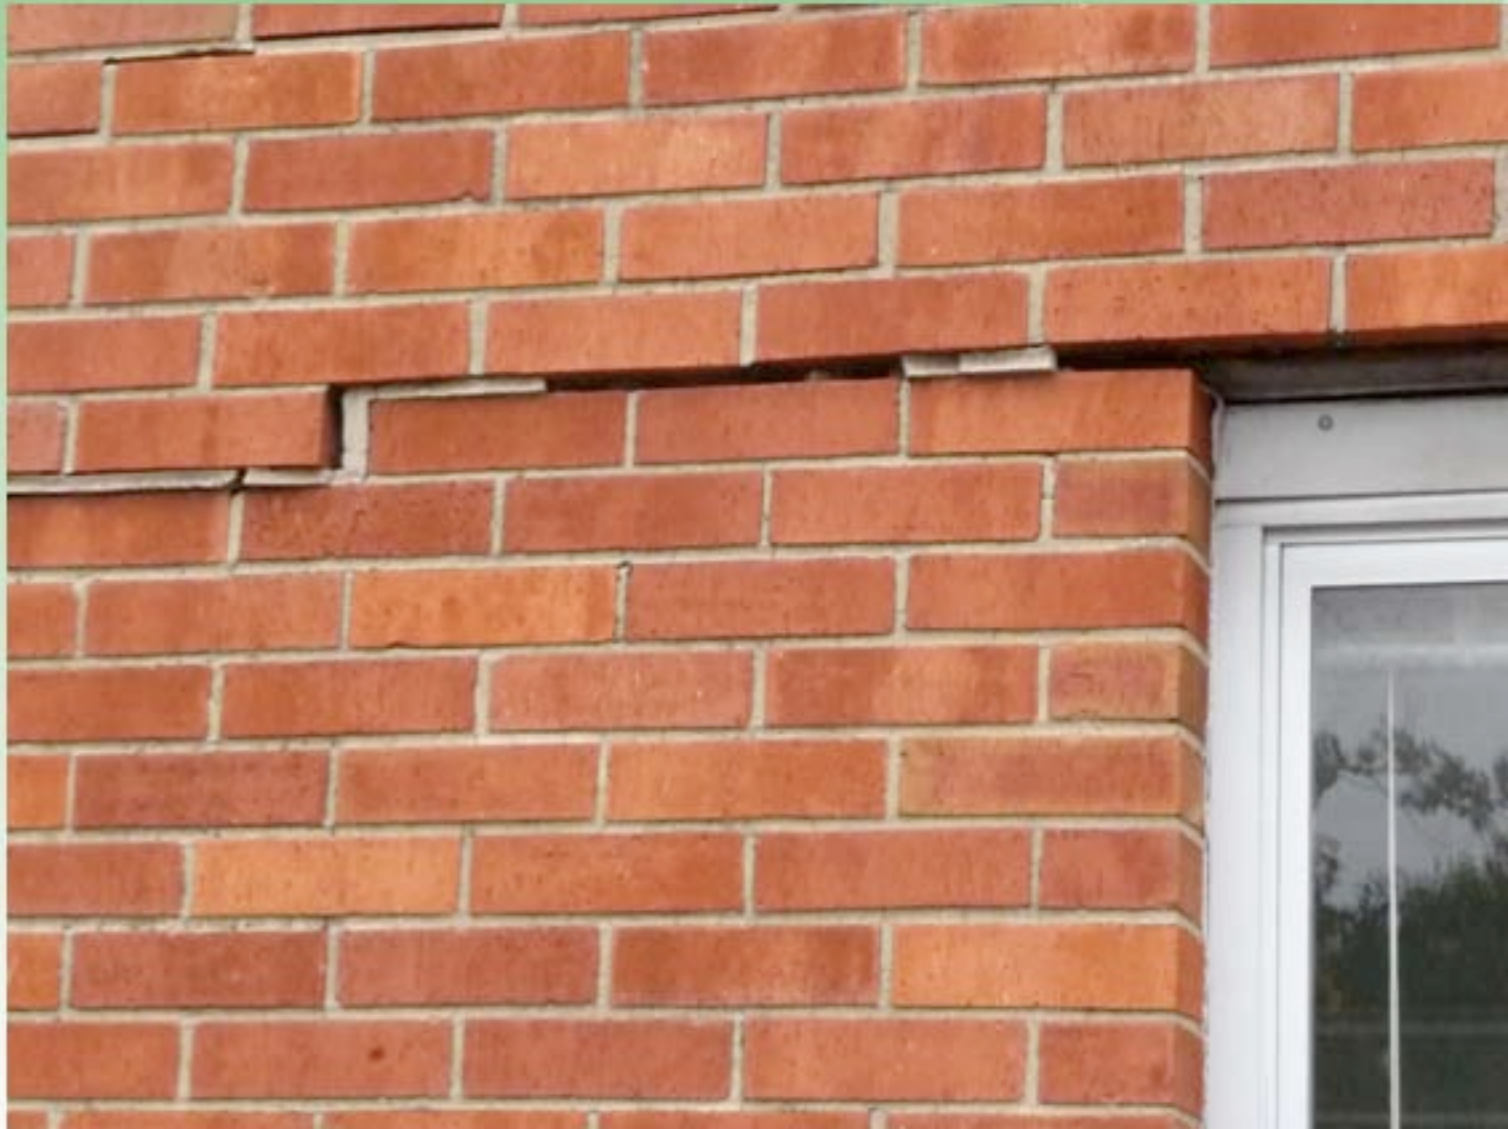
The upper brick is moving toward the left.

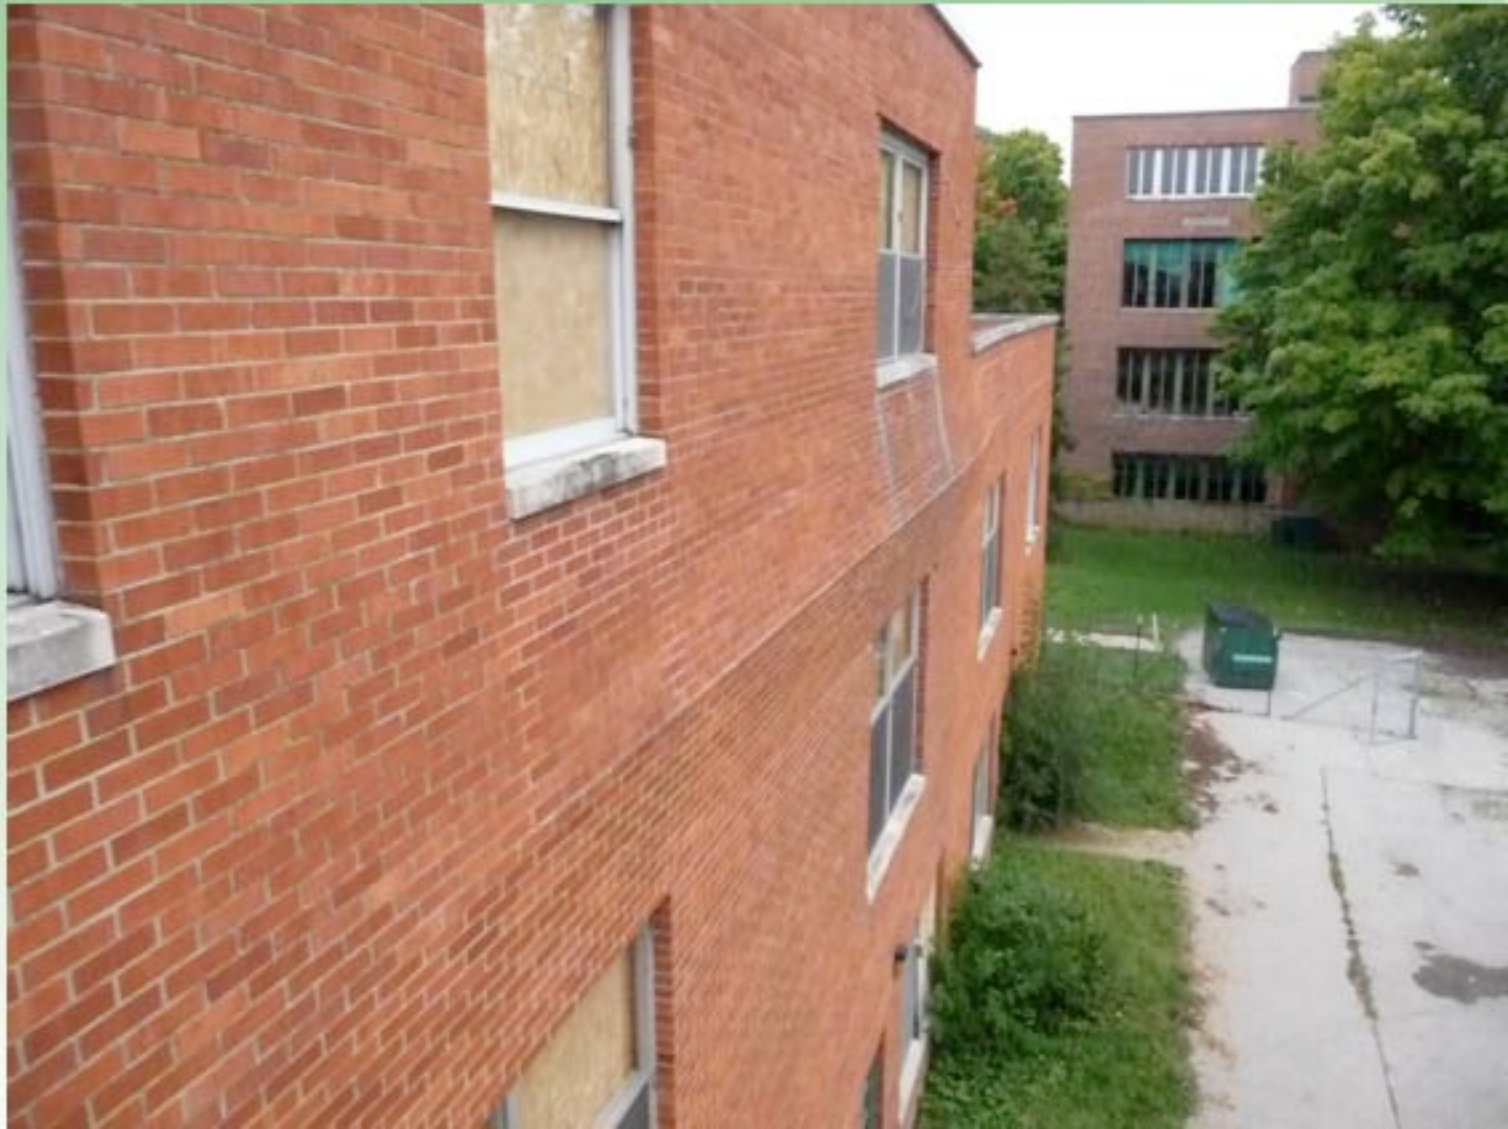
Library's South Wall Bulge

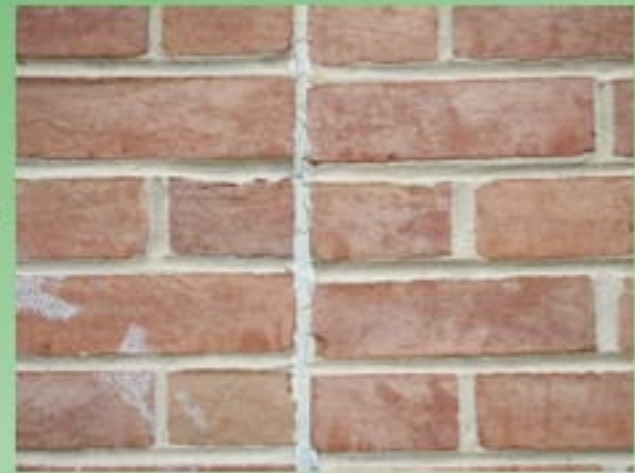
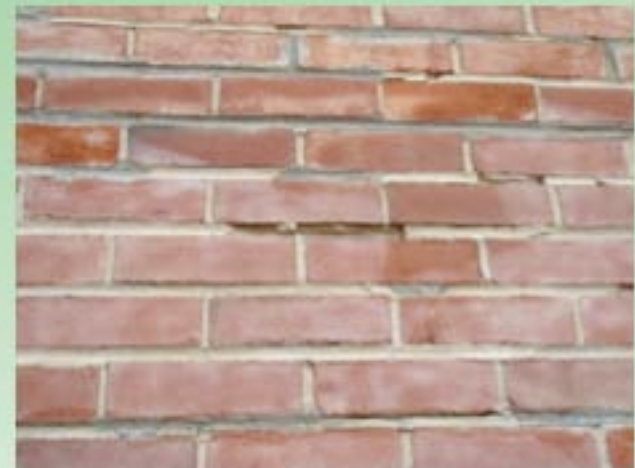
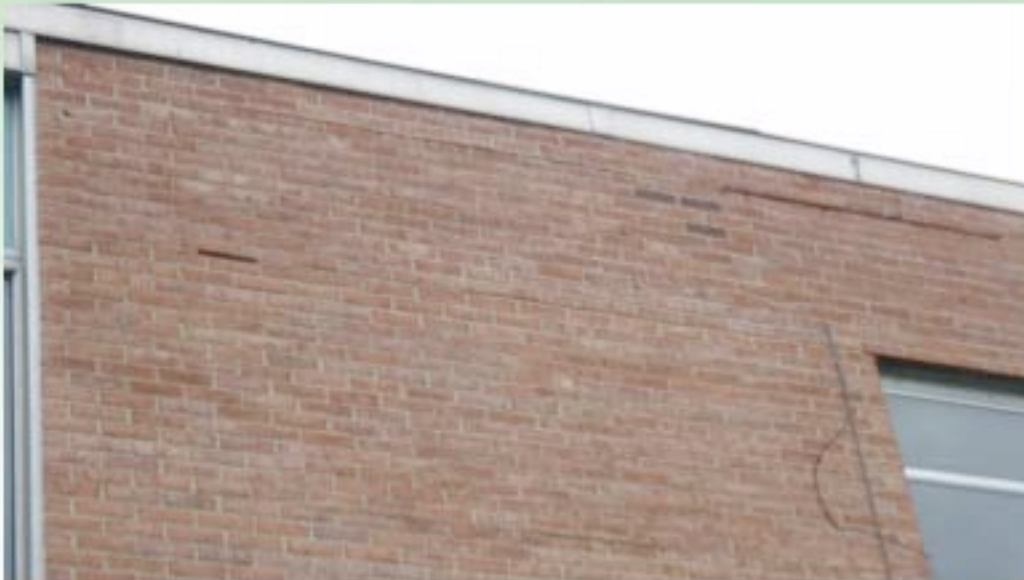
Expansion Joint

- Similar to Library Building,  
but less severe
- Joint reinforcement corrosion
- Mortar deterioration
- Moisture infiltration

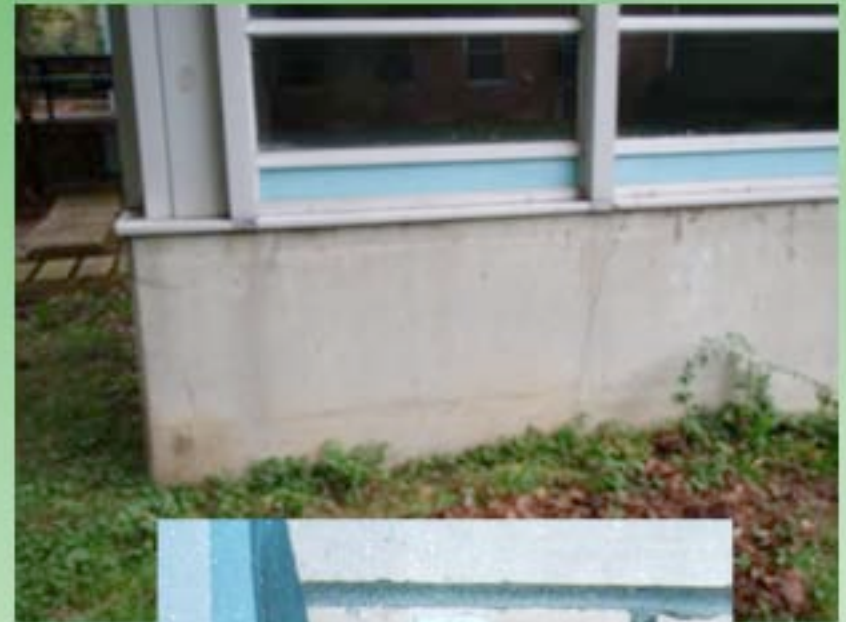
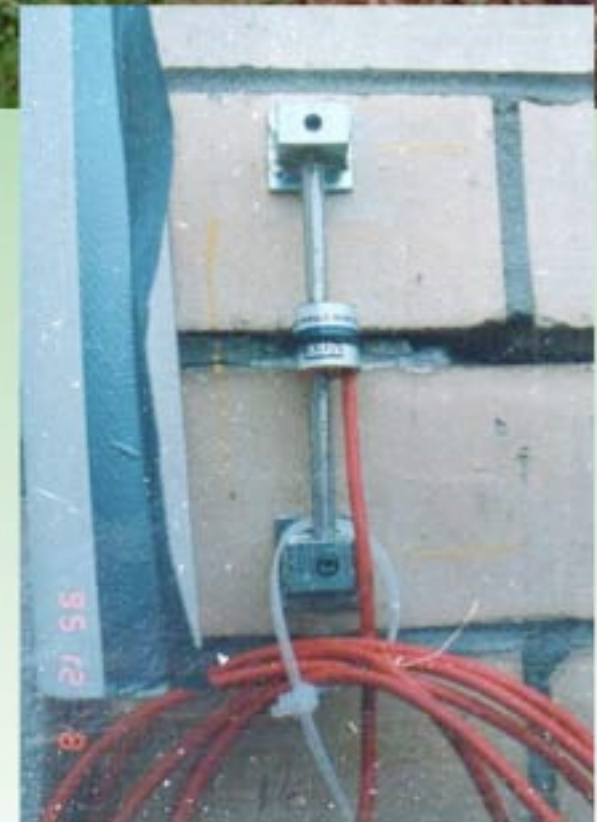
- Minor foundation movement at southeast corner
- Monitor crack opening - to determine necessity for repairs
